CONSERVATION *Showcase*

Program helps restore hydrology, wetlands, cultural resources on Yakama lands

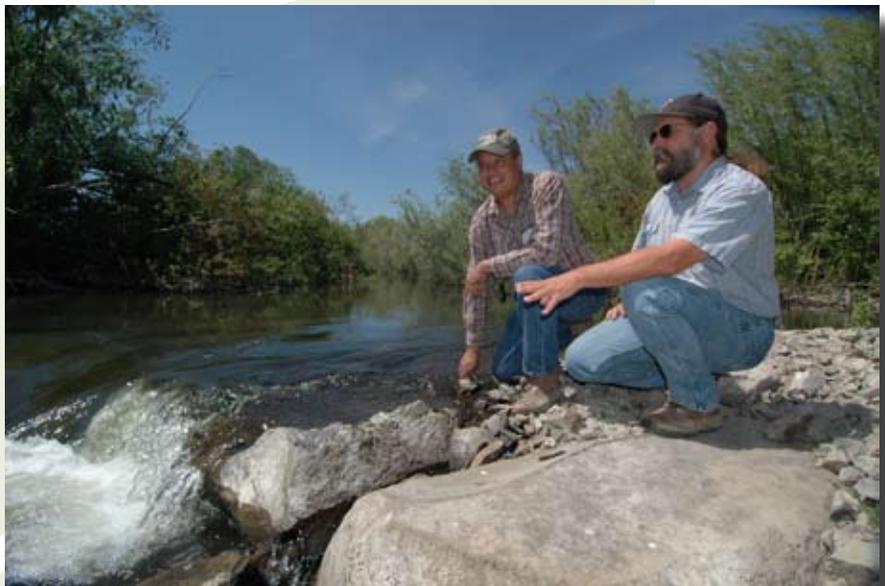
Tribal Wildlife Biologist Tracy Hames, right, and NRCS Tribal Liaison Roger Amerman, pause near one of the 28 engineered grade control structures that have helped restore the natural hydrology to Mid-Toppenish Creek.

"They look like real simple structures, but there's a lot of engineering in them," Mr. Hames says standing atop a row of the columnar basalt rocks, which comprise the structure and stretch across

the stream. "The rock is taken from a place here on the reservation and the structures are engineered such that they form and inverted 'V' so the point of the 'V' faces upstream, forcing the flow toward the middle of the stream to reduce bank erosion. They also act like natural cascades, making it much easier for the

fish to pass upstream – unlike many irrigation structures," he says, kneeling near the spot where the clear water cascades gently over the rocks into a shallow pool about a foot below. At first glance, it's hard to believe it's a man-made structure.

The rock water control structures are also kinder and gentler for fish. “Fish coming upstream can swim right through these points,” Hames says pointing to where the water spills over the rocks. “Because like a notch in a beaver dam,” he says, “the water doesn’t churn coming through the structure. That’s important for fish heading downstream, too.”

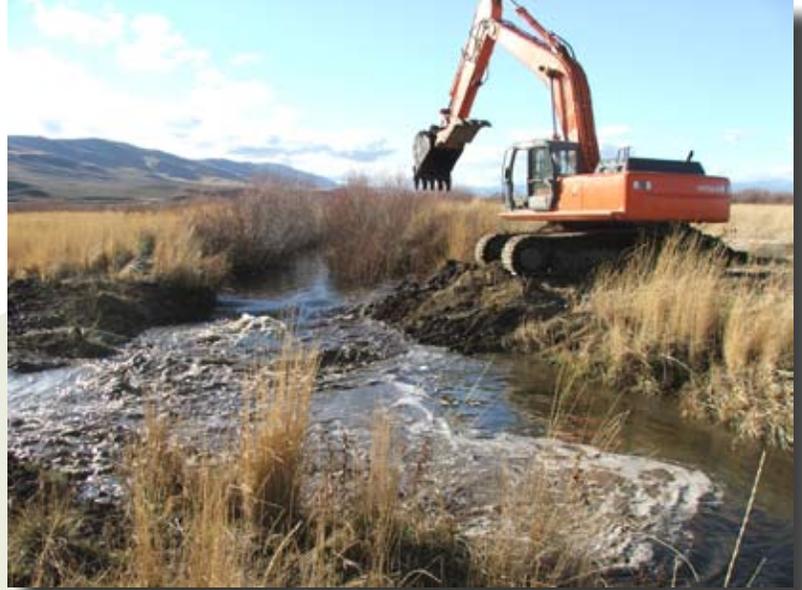
With the grade control structures in place, a backhoe operator breaches a temporary de-watering dam, allowing water from Mid-Toppenish Creek to flow along its historic channel. (Photo courtesy Tracy Hames.)

Through NRCS' program, the Tribe has installed 28, man-made grade control structures to lift the base level of the creek up several feet, in order to allow the beavers to begin restoring it again and to allow the floods to perform their hydrologic role.

Before designing and installing the structures, the NRCS, worked with the Tribe, Ducks Unlimited, and Geomax Inc. to develop a topographic survey of the floodplain. In the end, the 28 grade control structures affected 1600 acres of restored floodplain wetlands.
